1. EXISTING CONDITIONS | **PHOTOS OF CURRENT STATE**

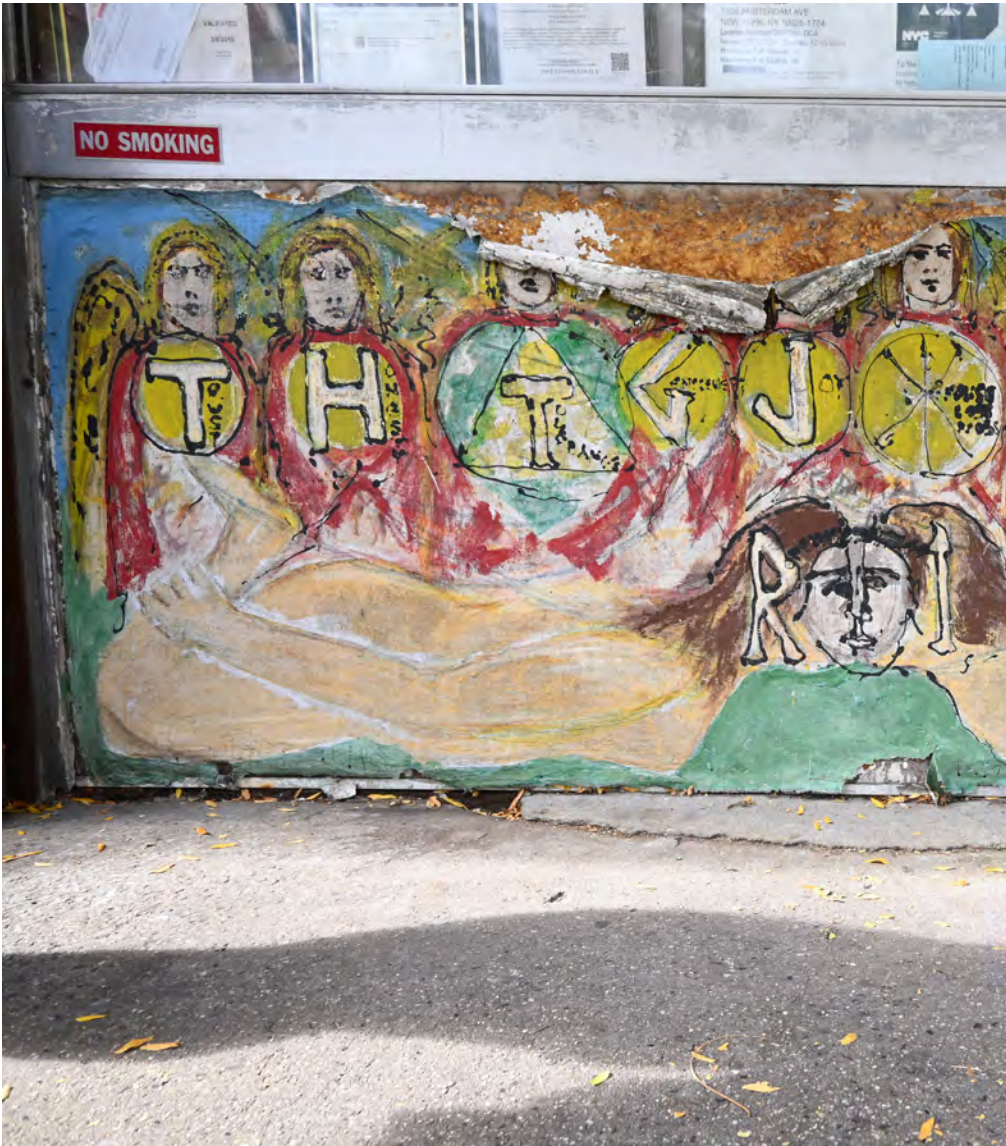
Photo of current state: original painting on vinyl is pilling off.

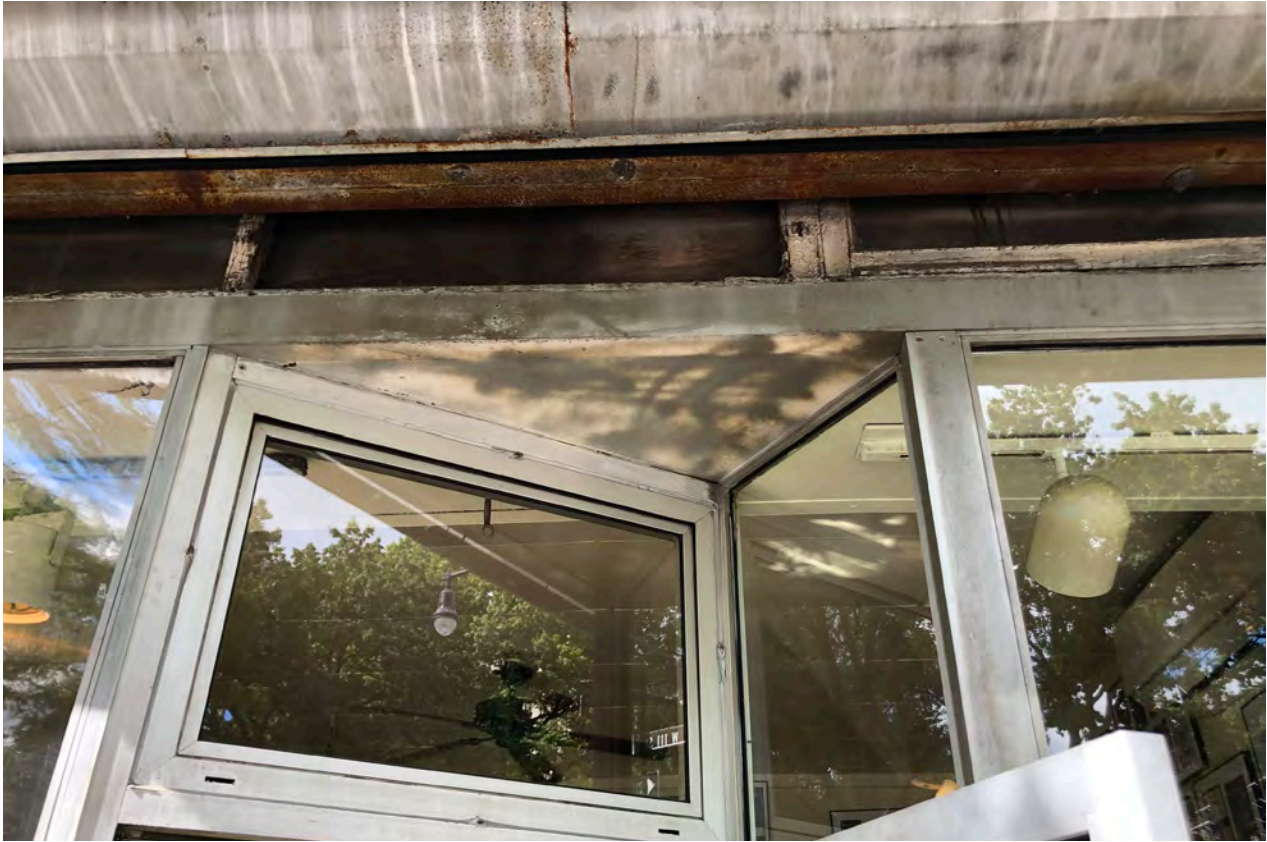
Photo of current state: facade is made of aluminum parts, wood frames and acrylic filling.

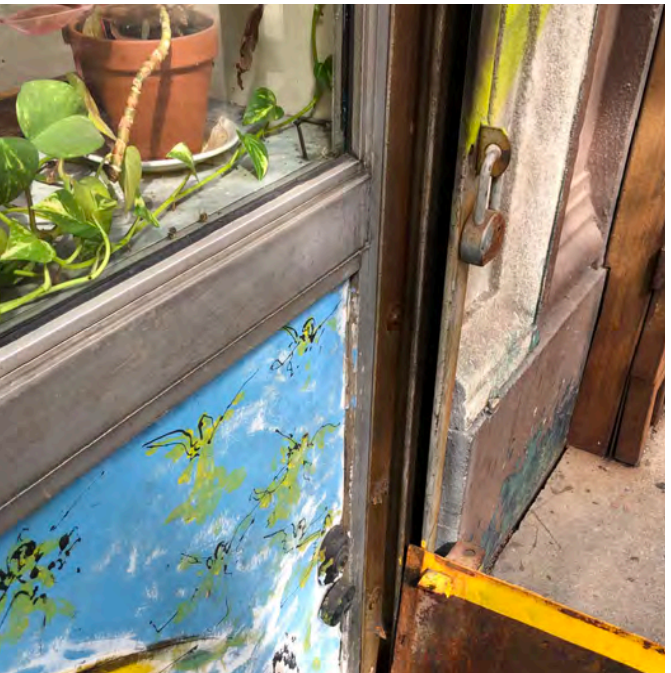
Photo of current state: roll-up gate track is rusty.

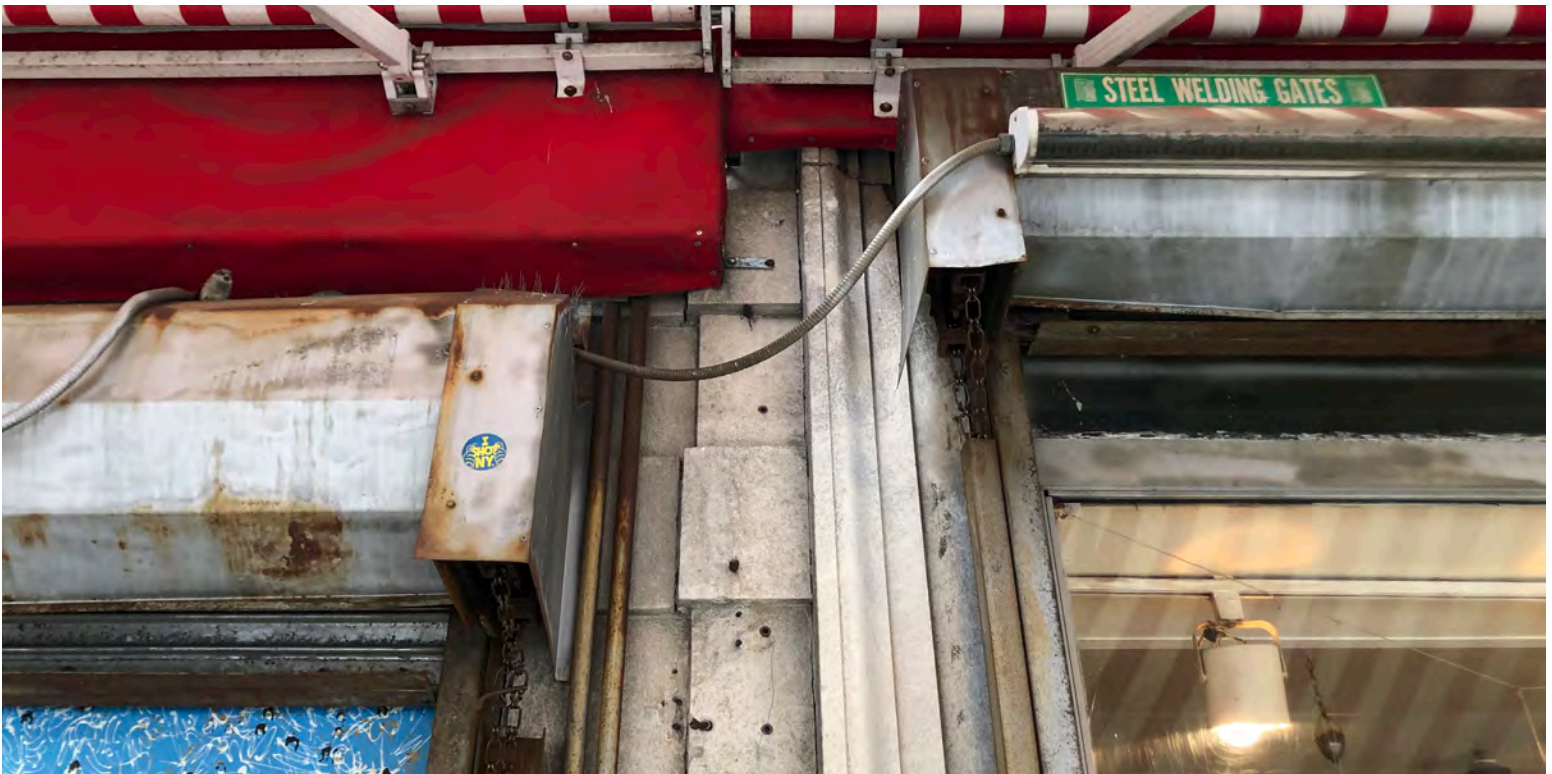
Photo of current state: outside lighting was an afterthought and electric installation is precarious.
